BRIDGE 36 – Raceway Road
Steel multi-plate culvert
Jericho, VT

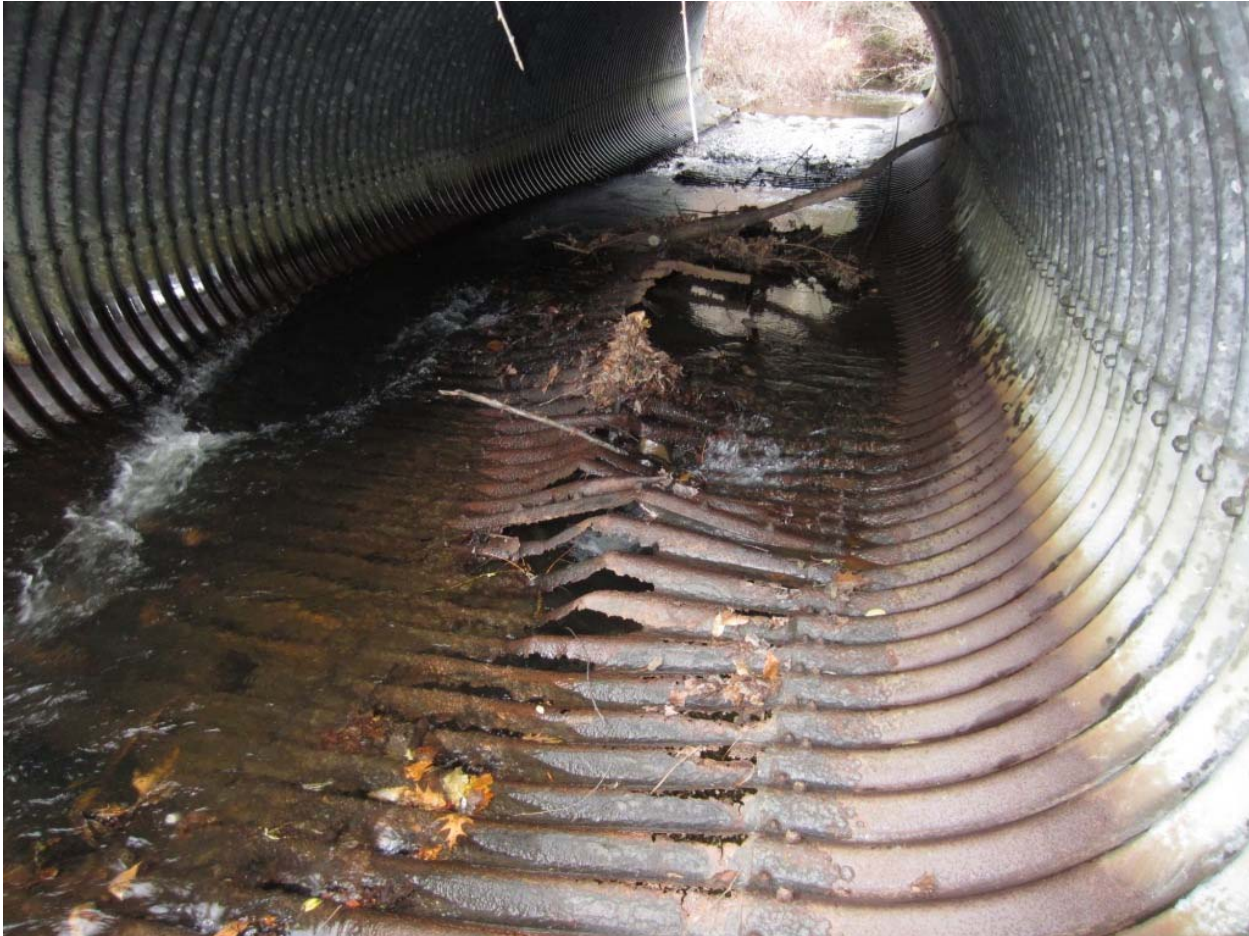
100% section loss of steel at culvert invert (floor). Distortion and heaving of steel at invert. Water is flowing beneath the culvert removing bedding material.
